# Manhole Inspection Summary

Manhole # S37WW\_020MH

Insp Date: **1/4/07 10:23 AM**

**Location** Address: **3026 GREENMOUNT AVE**

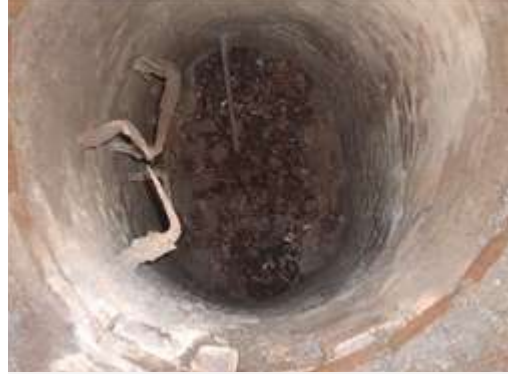
Top View

Barrel infiltration. Corroded and missing steps. Channel debris.

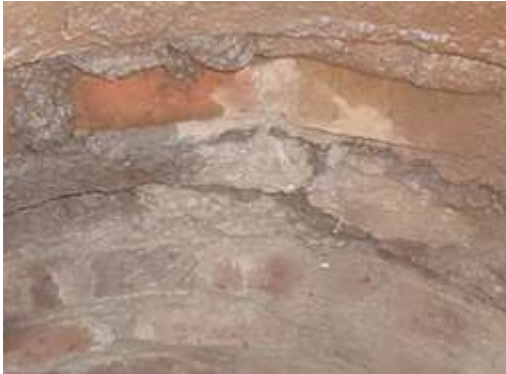
Defect

Frame leaks. Adjustment deterioration and infiltration.

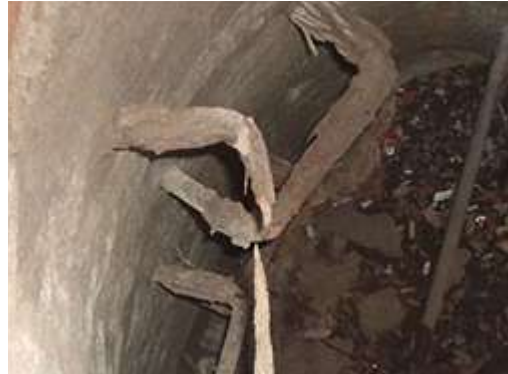
Defect

Barrel infiltration. Corroded and missing steps.

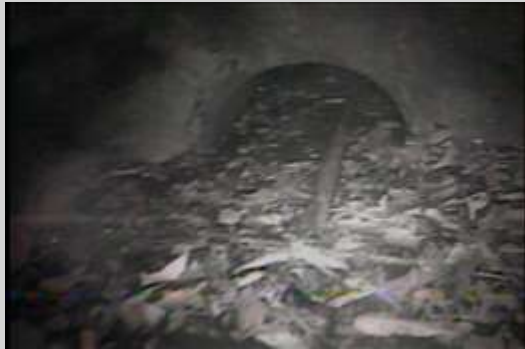
8 in. Circular Gravity Sewer  
Pipe Out @ 12 O'Clock

Deposits: ☐ None ☒ **Mud** ☐ Sludge ☒ **Debris** ☐ Grease

Silt Depth: **6** (in.) Deposits Extent: **Heavy**

Infiltration: **Evidence** Pipe Seal Cond: **Unknown**
